Manhole Inspection Summary

Manhole # S01EE2023MH

Location Address: **6307 Western Run Dr**

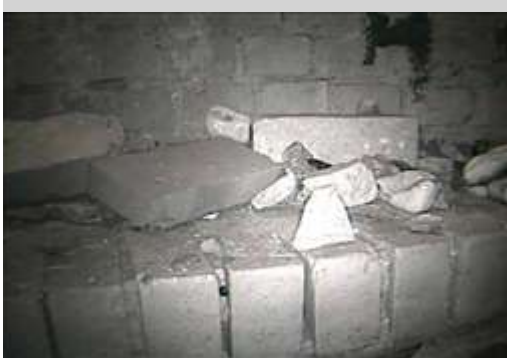
Defect

Comments **Heavy debris on bench**

Bench ☒ Exists Material: **Brick** ☐ Parged ☒ **Debris** (not Condition related)

Condition: ☐ Sound ☐ Cracked ☐ Root Intrusion ☒ **Deteriorated** ☐ Leaks ☒ **Debris**

heavy debris on bench

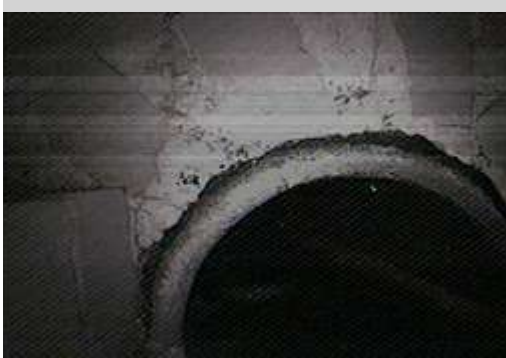
Defect

pipe seal

Infiltration: **None** Pipe Seal Cond: **Cracked**

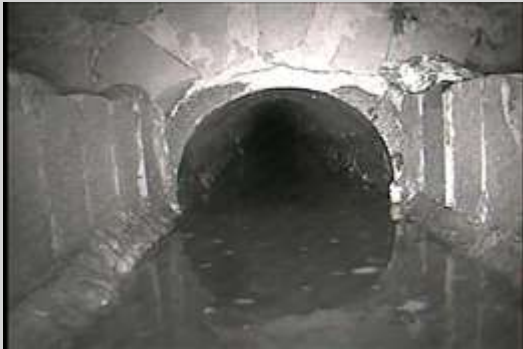
8 in. Circular Gravity Sewer Pipe Out @ 12 O'Clock

Deposits: ☐ None ☐ Mud ☐ Sludge ☒ **Debris** ☐ Grease

Silt Depth: **0.25** (in.) Deposits Extent: **Light**

Infiltration: **None** Pipe Seal Cond: **Sound**

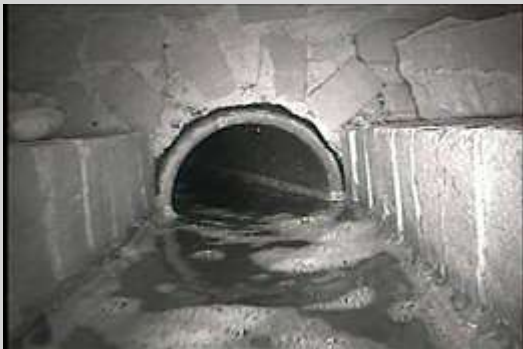
8 in. Circular Gravity Sewer Pipe In @ 6 O'Clock

Deposits: ☐ None ☐ Mud ☐ Sludge ☒ **Debris** ☐ Grease

Silt Depth: **0.25** (in.) Deposits Extent: **Light**
